TIMELESS STAINLESS ARCHITECTURE

Reference Book Series No 11 023

Timeless Stainless Architecture

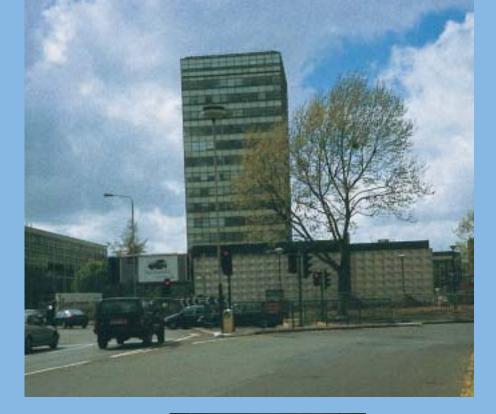
These 1999 photos of the Elephant & Castle Sub-Station illustrate that industrial buildings can remain attractive and relatively clean if an appropriate stainless steel and a smooth surface finish are specified. The design encourages natural rain cleaning and there is plentiful rain.

LOCA	TION	Newington Causeway, London, United Kingdom
DESCI	RIPTION	This single-story listed building is protected from modification. It is in central London on the southern side of the Thames River and houses an electrical sub-station.
ENVIR	CONMENT	Near the coast in an urban location that is exposed to dust and high levels of vehicle emissions.
COMF	PLETED	1962
ARCH	IITECT	London County Council
CON	FRACTOR	Morris Singer (now Crittal Construction Ltd.)
OWN	ERS	London Transport
CURT	Stainless steel Maintenance Condition	Stainless steel exterior wall panels with a pressed pattern Type 316 stainless steel, 0.028 inch (0.711mm) thick with a 'Staybrite' (buffed 2B) finish produced by Firth Vickers (surface roughness R _a 12 micro inches or 0.3 microns) No cleaning was planned and none has been done. Excellent. The stainless steel is shiny and stain-free with some minor dents. Natural rainwater washing has prevented accumulations of airborne contaminants.

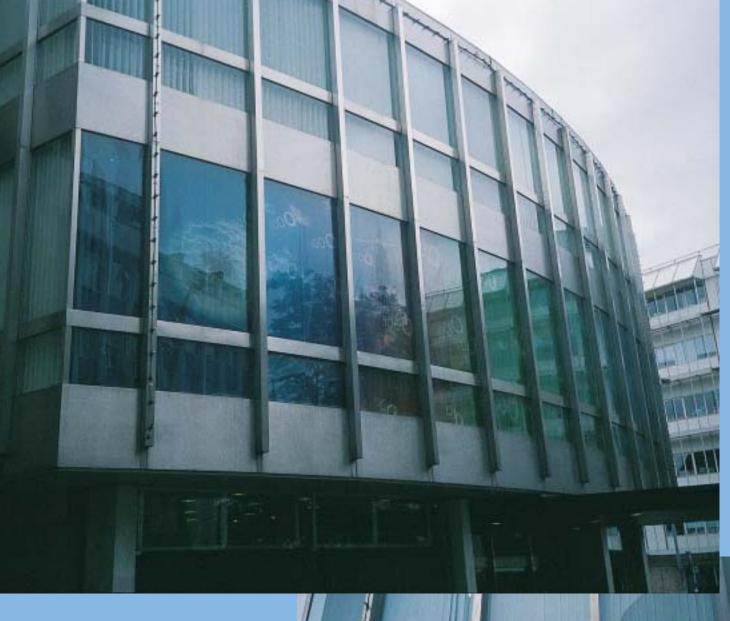
The Lewisham Civic Centre has never been cleaned and dirt accumulation is evident in these 1999 photos. No corrosion is visible and cleaning would restore the building to its original appearance.

LOCATION		Catford Road, Lewisham, London SE6, United Kingdom
DESC	RIPTION	Three-story local government office building
ENVIF	RONMENT	Near the coast in an urban location that is exposed to heavy automotive pollution and dust.
COMI	PLETED	1971
ARCH	HITECT	Lewisham Borough Architects
CON	TRACTOR	Culford Metal Industries
OWN	IERS	Lewisham Borough Council
CURT	AIN WALL	The second and third floors have stainless steel mullions, rails and spandrel panels.
	Stainless steel	Type 316 stainless steel
	Maintenance	The maintenance department has no record of ever cleaning the building.
	Condition	The stainless steel is quite dull in appearance. There is some visible discolouration, which appears to be dirt accumulation that could be removed by cleaning. There is no visible corrosion.

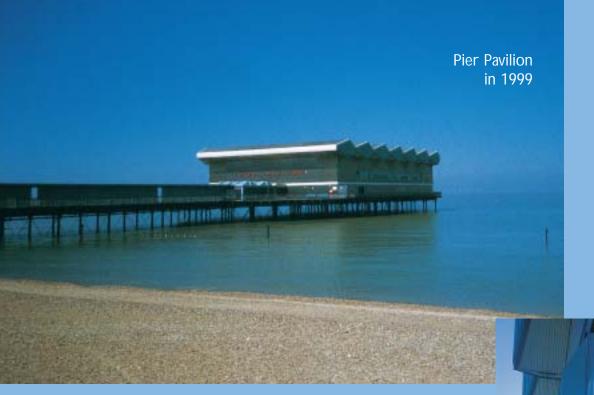
The Pier Pavilion has never been cleaned and it is splashed with seawater spray. There is some superficial corrosion staining, particularly in sheltered areas that are not washed by rainwater. Regular cleaning would remove the stains and prevent recurrence.

LOC	ATION	Herne Bay, Kent, United Kingdom
DESC	CRIPTION	A two to three-story sports centre on the end of an ocean pier.
ENV	RONMENT	A low-pollution, severe marine environment with seawater spray exposure.
COM	1PLETED	1976
ARC	HITECT	John C. Clague
CON	ITRACTOR	H. H. Robertson Ltd.
OWI	NERS	Herne Bay County Council
CUR	TAIN WALL	The external corrugated or profiled stainless steel cladding has a trapezoidal cross section and is held in place with stainless steel rivets.
	Stainless steel	Type 316 stainless steel with a 2B finish (surface roughness of R _a 14 micro inches or 0.35 microns)
	Maintenance	No cleaning was intended and none has been carried out.
	Repair/replacement	Some stainless steel panels were replaced due to accidental damage when equipment was lifted into the building by crane. The newer stainless steel panels are visibly cleaner than the older panels.
	Condition	Despite the lack of recommended maintenance and the direct exposure to seawater spray which deposits salt on the stainless steel, it is in very good condition. There is some superficial staining. Although this is clearly visible at close range, it is not obvious from the shore end of the pier. The staining could be removed by cleaning. There is staining around some but not all of the rivets. Different rivet materials may have been used. The building has a mixture of exposed and roof-overhang-sheltered stainless steel cladding. The sheltered areas are not washed by the rain and have more dirt and salt deposits.
